# Vehicle Inspection Report

**Reg:** HN13MZL

Report Date: 26/07/2017 6:54PM

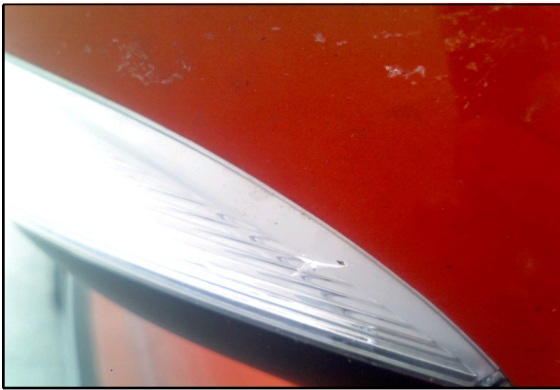
| Damage Location | Fault | Damage | Qty | Cost | Total |
|---|---|---|---|---|---|
| Door Mirror Glass os | Broken | Replace | 1 | £0.00 | £0.00 |

**osf wing mirror**
