# Vehicle Inspection Report

**Reg:** BGZ7293

Make: Renault	Fuel: D	Date First Reg: 31/03/2016
Model: Megane 1.5 Dynamique Nav Dci	Transmission: Manual	No Keepers: 1
Engine Size: 1.5	Gears: 6	Colour: Silver
Doors: 5	Mileage: 18999	Soft Top: No
Body Type: Hatchback	Declaration: Not Checked	Taxi/Private Hr: No
Vendor: RCI Vision	Yr of Manu: 2016	Acc Damage: No
Other:

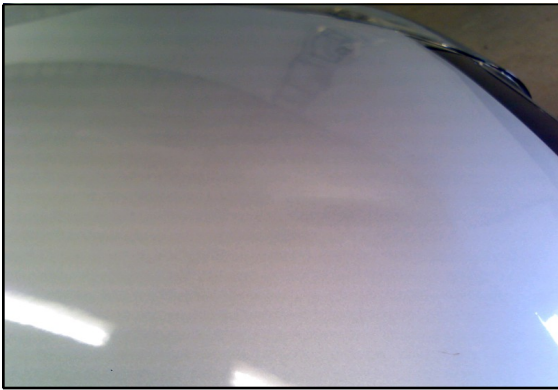
**bonnet**

Damage Location	Fault	Damage	Qty	Cost	Total
Bumper Rear	Scratched	Machine Polish	1	£12.00	£12.00
Roof	Scratched	Machine Polish	1	£12.00	£12.00
Wheel nsf	Scratched	Refinish	1	£40.00	£40.00
Qtr Panel nsr	Dented	Refinish	1	£113.00	£113.00
C Post os	Scratched	Machine Polish	1	£12.00	£12.00
B Post ns	Scratched	Machine Polish	1	£12.00	£12.00
Door osf	Dented	Refinish	1	£113.00	£113.00
Bumper Front	Scratched	Refinish	1	£86.00	£86.00
Bonnet	Dented	Repair and Refinish	1	£138.00	£138.00
				Damage Cost Total:	£538.00
				Damage Cost Total (Inc VAT):	£645.60
