Vehicle Inspection Report

Reg: LMN267X

Report Date: 12/05/2017 1:42PM

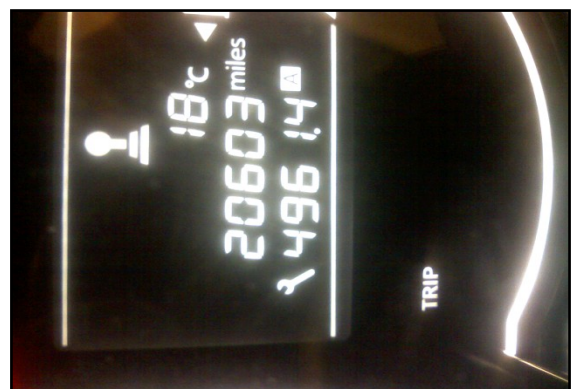
Speedo Reading

Make: Nissan	Fuel: P	Date First Reg: 01/04/2015
Model: Note Acenta -	Transmission: Manual	No Keepers:
Engine Size:	Gears: 5	Colour: blue
Doors: 5	Mileage: 20603	Soft Top: No
Body Type: MPV	Declaration: Not Checked	Taxi/Private Hr: No
Vendor: RCI Vision	Yr of Manu:	Acc Damage: No
Other:

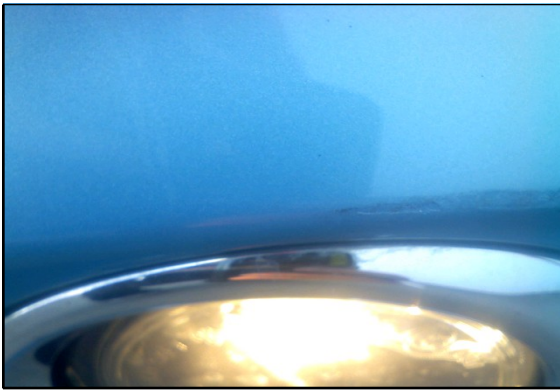
FRONT BUMPER

Damage Location	Fault	Damage	Qty	Cost	Total
Tailgate	Dented	PDR Smart Repair	1	£20.00	£20.00
Wheel nsf	Scratched	Refinish	1	£40.00	£40.00
Tailgate	Dented	PDR Smart Repair	1	£20.00	£20.00
Door nsr	Scratched	Refinish	1	£113.00	£113.00
Bumper Front	Scratched	Refinish	1	£86.00	£86.00
Wing nsf	Chipped	Touch In Smart Repair	1	£12.00	£12.00
				Damage Cost Total:	£291.00
				Damage Cost Total (Inc VAT):	£349.20
