# Vehicle Inspection Report

**Reg:** RFZ4802

Make: Renault	Fuel: P	Date First Reg: 14/02/2014
Model: Captur 0.9 D-que M-nav Nrg Tc	Transmission: Manual	No Keepers:
Engine Size: 0.9	Gears: 5	Colour: Black
Doors: 5	Mileage: 35618	Soft Top: No
Body Type: Hatchback	Declaration: Not Checked	Taxi/Private Hr: No
Vendor: RCI Vision	Yr of Manu: 2014	Acc Damage: No
Other:

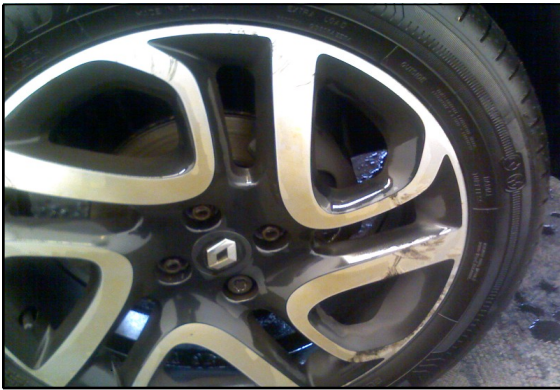
**osf wheel**

Damage Location	Fault	Damage	Qty	Cost	Total
Door osr	Dented	PDR Smart Repair	1	£20.00	£20.00
Wheel osf	Scratched	Refinish	1	£40.00	£40.00
Door osf	Dented	PDR Smart Repair	1	£20.00	£20.00
Bonnet	Chipped	Touch In Smart Repair	1	£12.00	£12.00
Qtr Panel nsr	Dented	PDR Smart Repair	1	£20.00	£20.00
Bumper Front	Scratched	Refinish	1	£86.00	£86.00
Wheel nsf	Scratched	Refinish	1	£40.00	£40.00
				Damage Cost Total:	£238.00
				Damage Cost Total (Inc VAT):	£285.60
